BRIDGE DAMAGE AND RECONSTRUCTION FROM TOHOKU REGION PACIFIC COAST EARTHQUAKE

Nobuya KAWATA^a, Yasushi TAKAHASHI^b, Mitsuru SUGIYAMA^b, Tomohiro OBUCHI^b

^a Shin Nippon Giken Engineering Co., Ltd., Sendai Office, 1-2-10-17, Aoba, Sendai, Miyagi, Japan
kawata@sng.co.jp

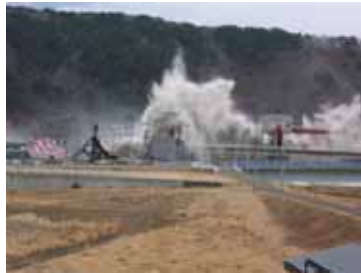
The bridge was subjected to the tsunami waves directly, as shown in photo 1. And the waves crashed on the dam downstream and splashed. The superstructure did not fall down due to decreasing of the tsunami wave energy. However the railing was extremely distorted outward, as shown in photo 2.

Photo 1 : Tsunami waves

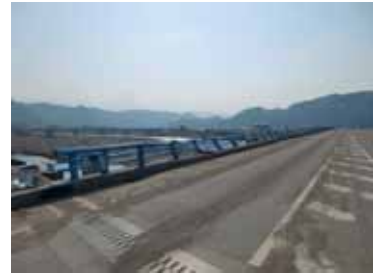
Photo 2 : Railing damage

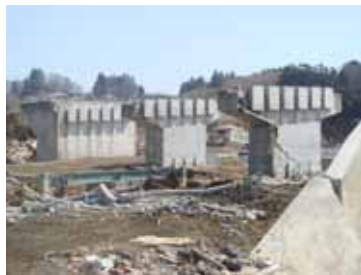
The bridge was consisted of the several post-tension simple T-beams. All superstructure fell down by the tsunami wave, as shown in photo 3. The superstructure was attached to the substructure with the anchor bars, as shown in figure 2. Because the anchor bars were found to be still straight after the disaster, it is considered that the superstructure was moved up by the buoyancy and then was washed away by the flowing water pressure.

Photo 3 : Numata bridge

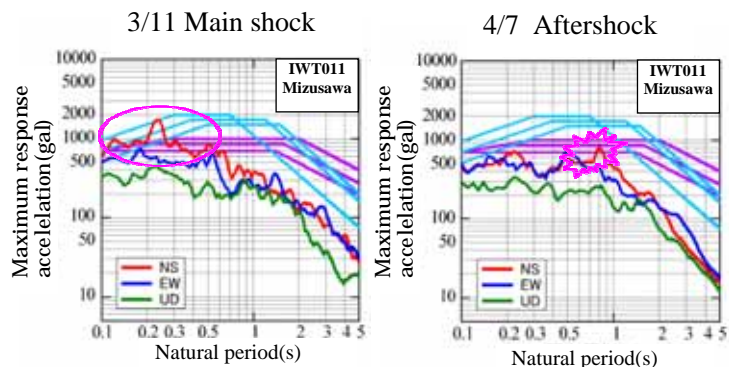
Figure 3: Response acceleration spectrum

Figure 3 shows the response acceleration spectrum which were using the seismic wave recorded near two bridges. The response acceleration spectrum of the main-shock is high in the short-period range. While, in the case of the aftershock, the peak is at 0.8 seconds which is similar to the natural period of two bridges. It is considered as the cause of the damages of two bridges.

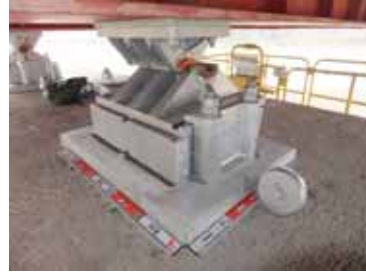
Fuji Bridge is shown in photo 4. The pin bearings were broken by the aftershock and the pins dropped as shown in photo 5. In the piers of this bridge, a tensile yield of the longitudinal reinforcement and the compression failure of concrete were observed at the upper part of the section where the amount of reinforcement was changed, as shown in photo 6 and 7.

Photo 5 : Bearing failure

To obtain the emergency transportation, a temporary repair work was carried out for the bearing. The time efficiency is important in reconstruction. Therefore, the method using shaped steel was adopted as shown in photo 8.

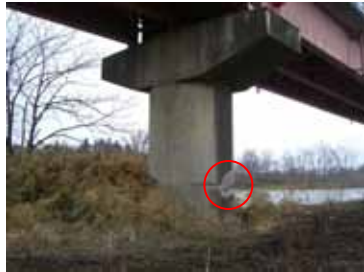
Photo 6 : Pier damage

In the reconstruction of the piers, to avoid the damaged portion from slip by possible aftershocks, the method of restraining the H-section steels around the piers by the wire was adopted. Situation and detail of the reconstruction were shown in the photo 9 and figure 4 respectively.

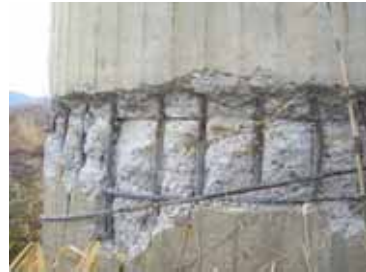
Photo 7 : Flexural failure

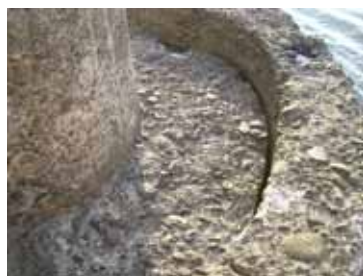
Koyagi Bridge is shown in photo 10. Since the top slab of the bridge foundation with open-caisson sagged and tilted, the column of the bridge tilted to the downstream side as shown in Photo11 and figure 5. The deformation of the railing as shown in photo 12 was caused by the displacement of foundation.

Photo 11 : Caisson damage

To confirm the possibility that the displacement progresses by the various factors including the traffic load and the possible aftershocks, the cause of the foundation displacement (e.g. top slab sagging) was investigated prior to reconstruction. As a result of the investigation, some voids under the top slab, passing-through cracks of the top slab, and 1 meter scouring were found. Since the result showed there was a possibility that the further displacement occurs, reconstruction was carried out as shown in figure 6.

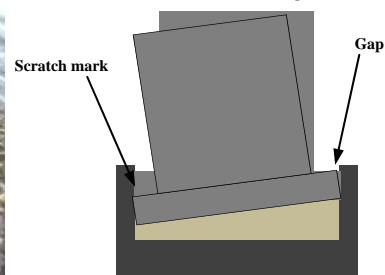
Figure 5 : Damage situation

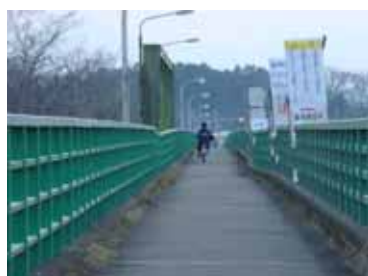
Photo 12 : Railing damage
