BRIDGE DAMAGE AND RECONSTRUCTION FROM TOHOKU REGION PACIFIC COAST EARTHQUAKE

Nobuya KAWATA^a, Yasushi TAKAHASHI^b, Mitsuru SUGIYAMA^b, Tomohiro OBUCHI^b

^a Shin Nippon Giken Engineering Co., Ltd., Sendai Office, 1-2-10-17, Aoba, Sendai, Miyagi, Japan
kawata@sng.co.jp

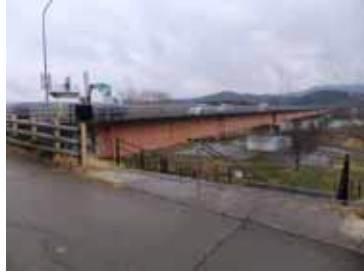
Photo 4 : Fuji Bridge

Fuji Bridge is shown in photo 4. The pin bearings were broken by the aftershock and the pins dropped as shown in photo 5. In the piers of this bridge, a tensile yield of the longitudinal reinforcement and the compression failure of concrete were observed at the upper part of the section where the amount of reinforcement was changed, as shown in photo 6 and 7.

To obtain the emergency transportation, a temporary repair work was carried out for the bearing. The time efficiency is important in reconstruction. Therefore, the method using shaped steel was adopted as shown in photo 8.

In the reconstruction of the piers, to avoid the damaged portion from slip by possible aftershocks, the method of restraining the H-section steels around the piers by the wire was adopted. Situation and detail of the reconstruction were shown in the photo 9 and figure 4 respectively.

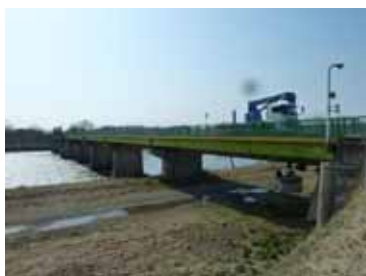
Photo 10 : Koyagi Bridge

Koyagi Bridge is shown in photo 10. Since the top slab of the bridge foundation with open-caisson sagged and tilted, the column of the bridge tilted to the downstream side as shown in Photo11 and figure 5. The deformation of the railing as shown in photo 12 was caused by the displacement of foundation.

To confirm the possibility that the displacement progresses by the various factors including the traffic load and the possible aftershocks, the cause of the foundation displacement (e.g. top slab sagging) was investigated prior to reconstruction. As a result of the investigation, some voids under the top slab, passing-through cracks of the top slab, and 1 meter scouring were found. Since the result showed there was a possibility that the further displacement occurs, reconstruction was carried out as shown in figure 6.
